# Kenya's huge railway project is causing environmental damage. Here's how

Kenya is constructing a railway line that connects the coastal port of Mombasa and the interior of the country. It is expected to terminate at Malaba, a town on the border with Uganda, and link up with other railways that are being built in East Africa. It's locally known as the Standard Gauge Railway (SGR).

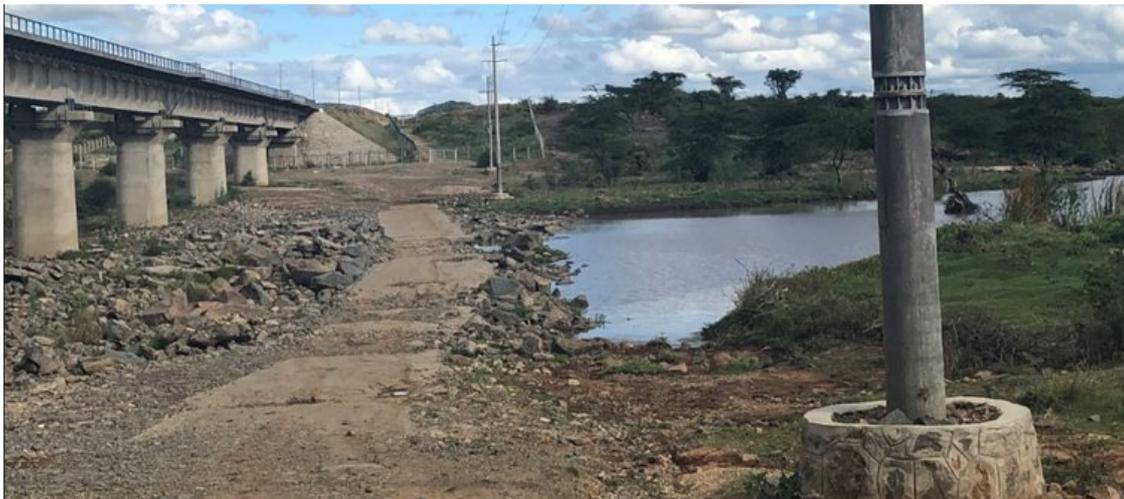
A blocked river in Kitengela.

In addition, silt from construction led to the blockage or drying up of rivers, notably the Empakashe and Mbagathi rivers around Nairobi. Most communities in these areas rely on the rivers for domestic consumption, watering their livestock and irrigation agriculture.

Floods have been a major challenge. To avoid cutting through the railway embankments, contractors rerouted natural surface water flows (such as streams) to the underpasses.

But this led to increases in the volume and speed of the water flow which caused flooding and soil erosion. This was compounded by the clearing of surrounding vegetation, which would usually slow water down.
