# Kenya's huge railway project is causing environmental damage. Here's how

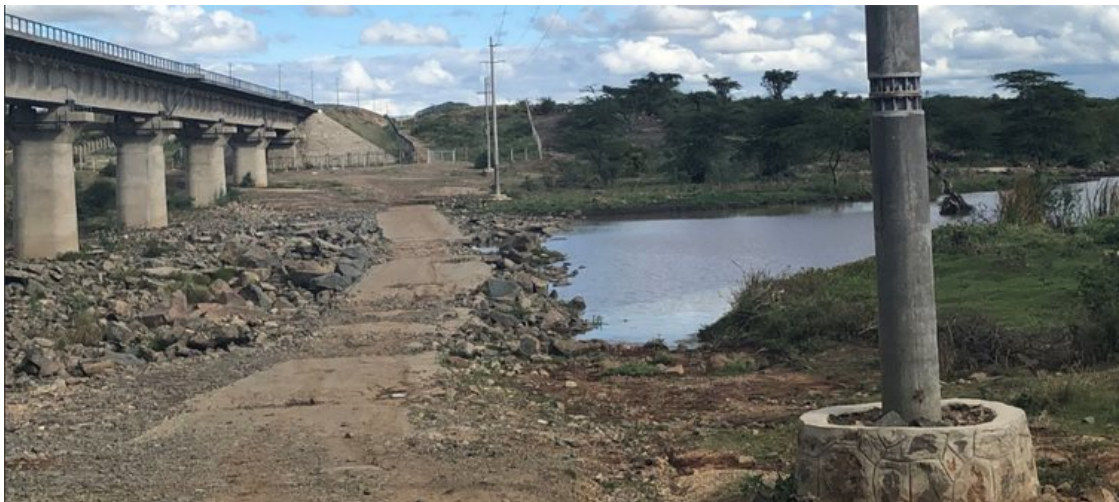
A blocked river in Kitengela.

In addition, silt from construction led to the blockage or drying up of rivers, notably the Empakashe and Mbagathi rivers around Nairobi. Most communities in these areas rely on the rivers for domestic consumption, watering their livestock and irrigation agriculture.
